SUBJECT: Govro Lake Dam Phase I Inspection Report  
(MO No. 31095)

GOVRO LAKE DAM

MISSOURI INVENTORY NO. 31095

PHASE I INSPECTION REPORT  
NATIONAL DAM SAFETY PROGRAM

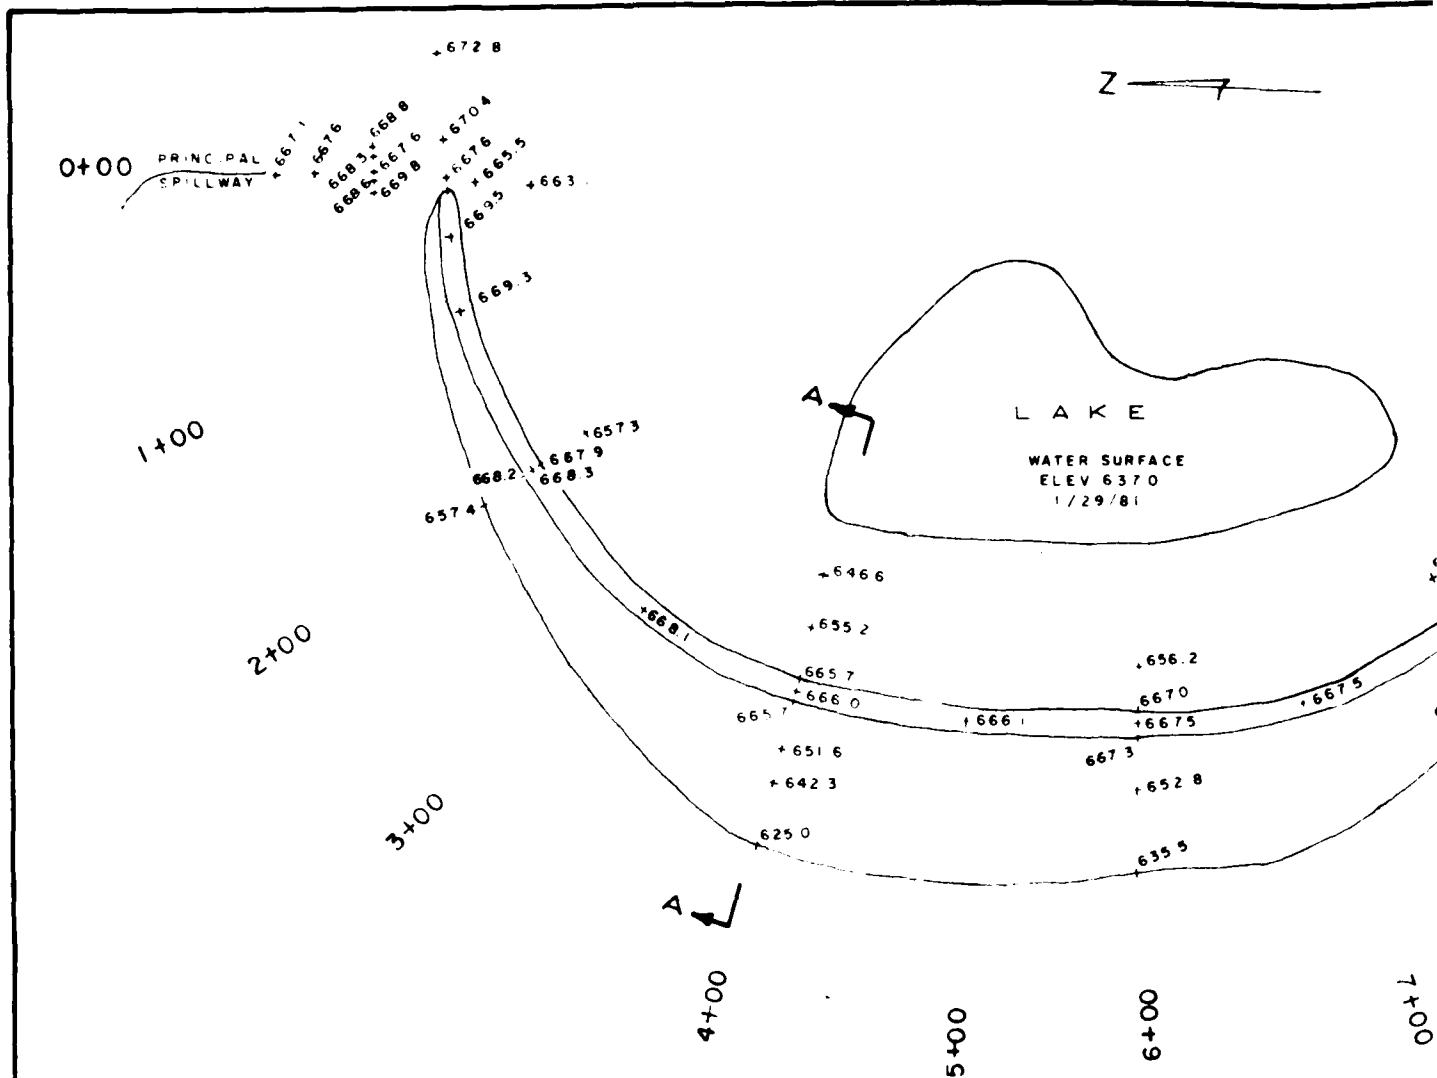
PLAN VIEW  
SCALE: 1" = 100'

BENCHMARK:  
TOP OF HOUSE FLOOR SLAB  
STA 0+70, 75 ft. LEFT  
ELEV. 670.0 M.S.L.

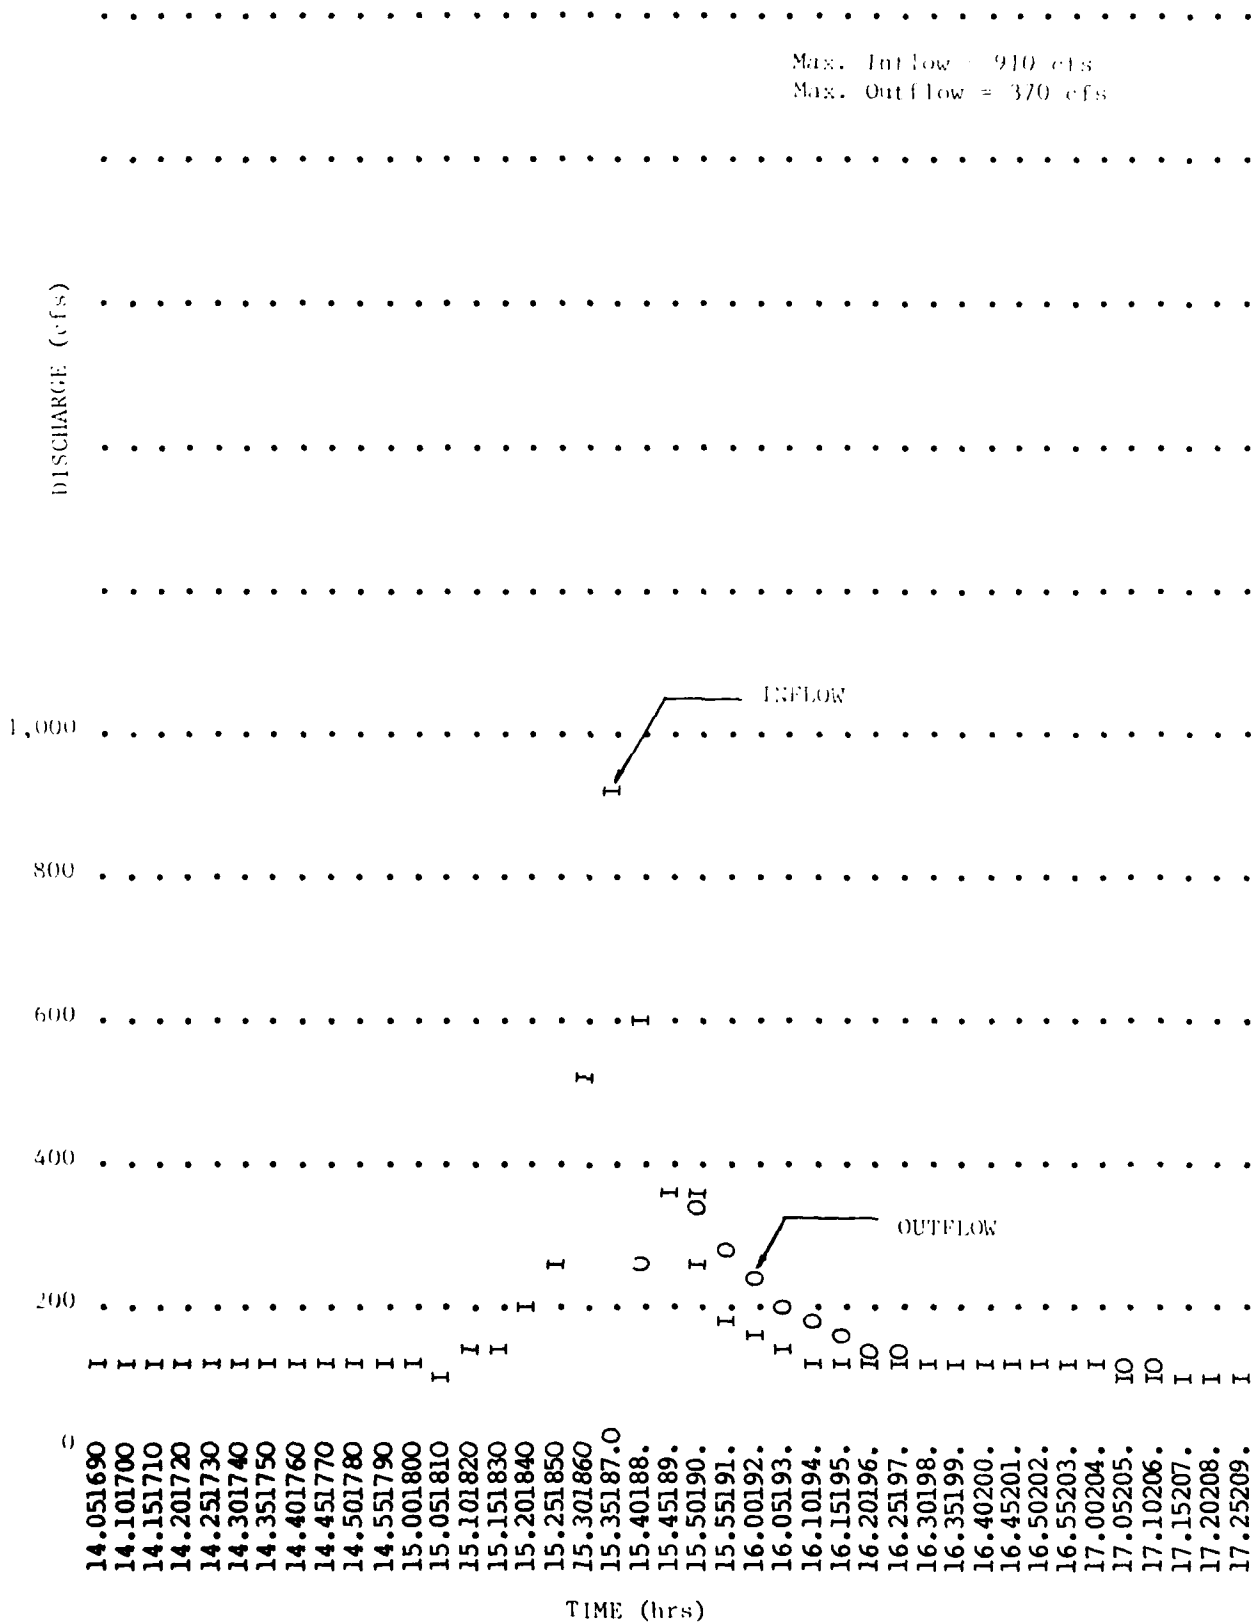
INFLOW-OUTFLOW HYDROGRAPH  
FOR THE PMF

ELEVATION STORAGE OUTFLOW	INITIAL VALUE	SPILLWAY CREST	TOP OF DAM	RATIO OF PMF 1.00	MAXIMUM RESERVOIR W.S.ELEV 666.90	MAXIMUM DEPTH OVER DAM 0.90	MAXIMUM STORAGE AC-FT 120.	MAXIMUM OUTFLOW CFS 367.	DURATION OVER TOP HOURS 8.50	TIME OF MAX OUTFLOW HOURS 15.75	TIME OF FAILURE HOURS 0.00
	657.20	666.00	666.00								
	66.	113.	113.								
	0.	0.	0.

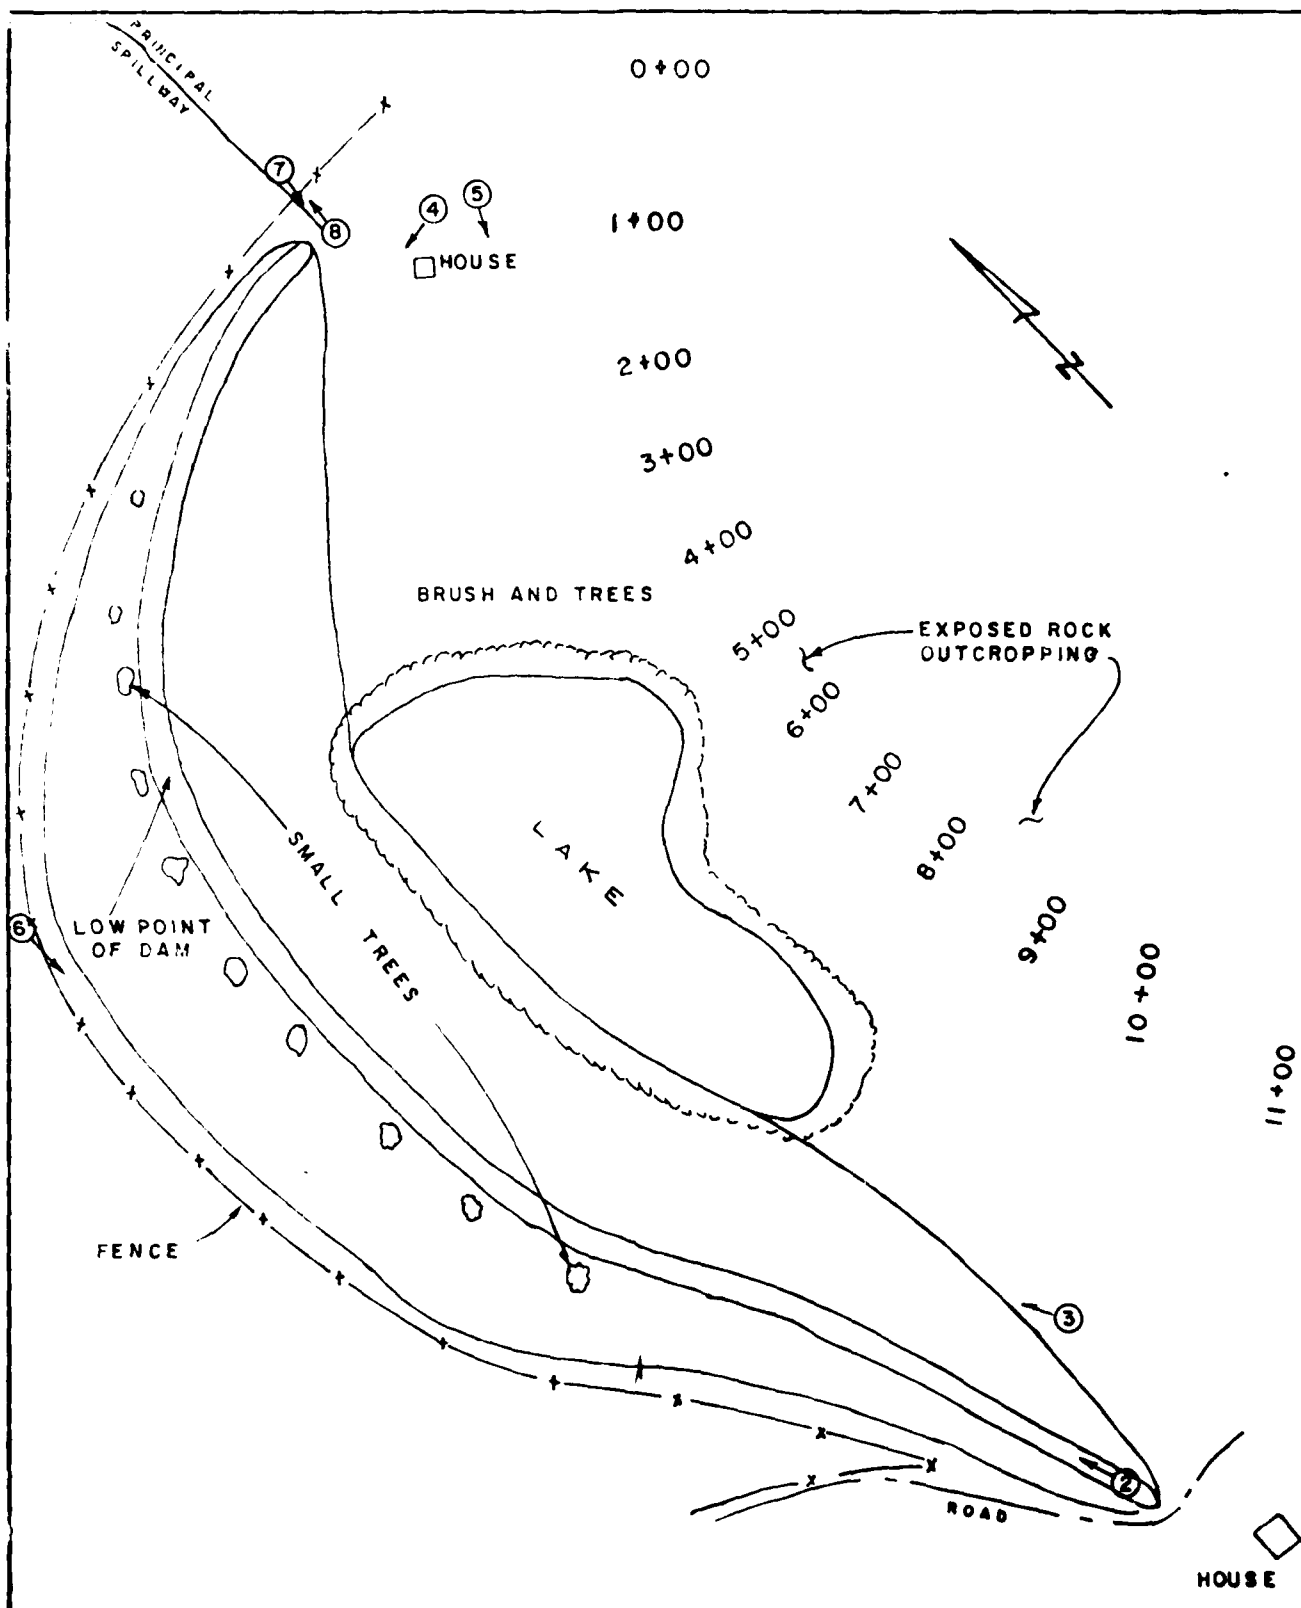
**PLAN SKETCH OF DAM**  
**GOVRO LAKE DAM**  
 STE. GENEVIEVE COUNTY, MISSOURI  
 MO. I. D. No. 31095

Photo No.	Description
1	Aerial view of Lake and Dam (looking East)
2	View of crest of embankment. Note brush and tree growth (looking North)
3	Upstream slope of embankment. Note tree growth (looking North)
4	Upstream slope of embankment near principal spillway. Note apparent low area of embankment and rock outcropping (looking West)
5	View of lake area (looking South)
6	Downstream slope of embankment. Note grass cover and scattered tree growth (looking South)
7	Principal spillway control section (looking South)
8	Principal spillway outlet channel (looking North)
